Manhole Inspection Summary

Manhole # S17S__004MH

Location Address: **2717 WILMARCO AV**

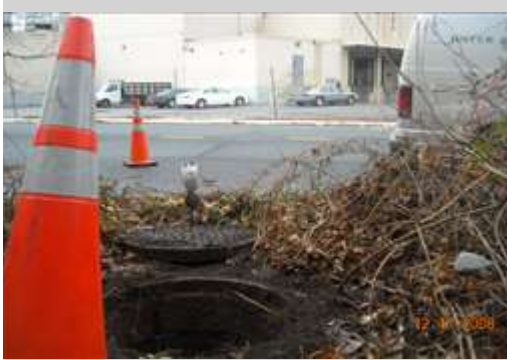
Location View

Comments **LOCATED WITH METAL DETECTOR IN WOODED AREA NEXT TO ROAD, BETWEEN TELEPHONE POLE AND SUPPORT CABLE. REMOVED BRUSH AND DEBRIS FROM OVER AND AROUND THE MANHOLE.**
